Sherlock Homes Inspection, LLC
2722 N 45th Rd.

Buyers Home Inspection Report

Property address: **109 Pleasant Street
Sunnyville, IL 70000**

Inspection date: **May 1, 2008**

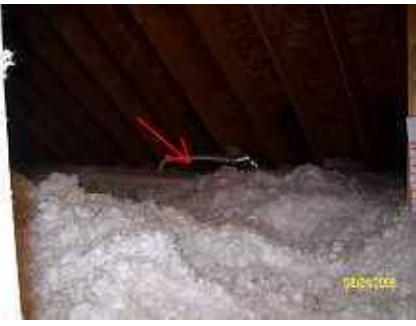
Photo 1

14) *Repair/Replace* - One or more exhaust fans terminate in the soffit vent. This is a conducive condition for wood destroying insects and organisms due to increased moisture levels in the attic from the exhaust air. A qualified contractor should install ducts and vent caps as necessary and as per standard building practices so exhaust air is vented outside. Better building practices call for R8 rated insulation on these ducts.

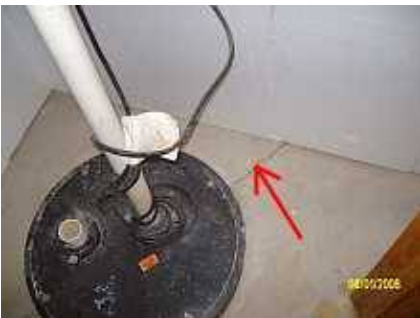
Photo 2

24) *Monitor, Comment* - Several cracks were noted in the basement floor. The cracks are typical concrete shrinkage cracks caused by concrete curing and do not appear to be a structural concern, however recommend monitoring to ensure this condition is stable.
